Title: DC2-PC I/O Conflict When Installed in ISA-bus Slot
Products(s): DC2-PC
Keywords: Windows, Communications, ISA-Bus, I/O Address
ID#: TN1001
Date: June 8, 1998

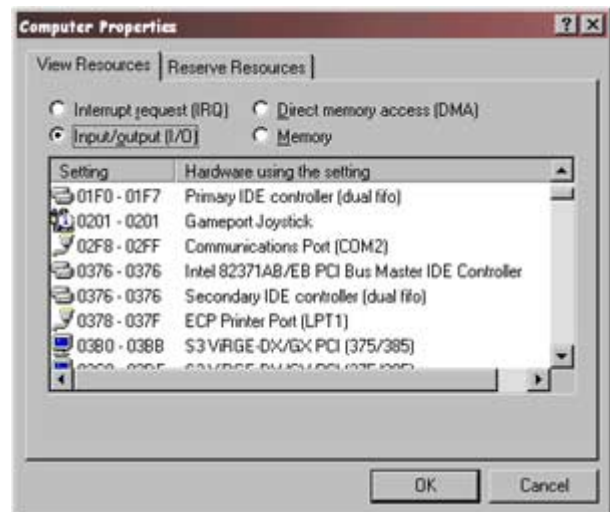
Figure 1: I/O Resources in Computer Properties

Windows 95 / 98 users may use the System Properties dialog to check for a conflict. Right-click on the "My Computer" icon and select properties. Click on the "Device Manager" tab, select "View devices by type" and double-click on the computer icon at the top of the list. In the "Computer Properties" dialog select Input / Output (I/O) and scroll through the list to find the address range in question (NOTE: the DC2-PC will not show up in this list). If another peripheral is using the address range in question you will need to re-address the DC2-PC or the other peripheral.
