**Title:** Motion Control API 2.0 Programs Refuse to Load  
**Products(s):** MCAPI  
**Keywords:** Error 1114, Program Load, DLL, Startup  
**ID#:** TN1021  
**Date:** January 13, 1999

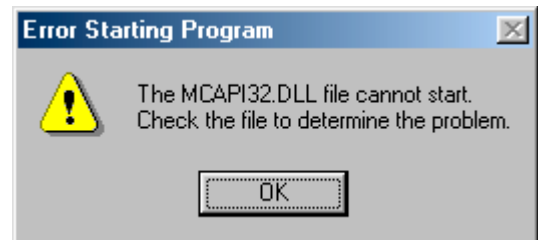
During initialization of the MCAPI DLL (dynamic link library) the current controller settings are read from the MCAPI.INI initialization file. A bug in the version 2.0 DLL would cause the DLL to abort loading if no configured controllers were found in the MCAPI.INI file. Applications would report a "DLL cannot start" error and quit, report no error and quit, or report a "Windows System Error #1114" (Windows 95/98) and quit.

To work avoid the problem always configure at least one controller for use with the MCAPI (release 2.0a to 2.0d), or upgrade to release 2.1a of the MCAPI. Please note that although the release 2.1a MCAPI DLLs will load with no motion controller configured, there is very little you can do with the API until you install and configure at least one motion controller.
