Title: Memory Conflicts – excluding DCX memory from available PC resources
Products(s): DCX-AT300, DCX-AT200, DCX-PC100
Keywords: Memory, Conflicts
ID#: TN1032
Date: October 6, 2000

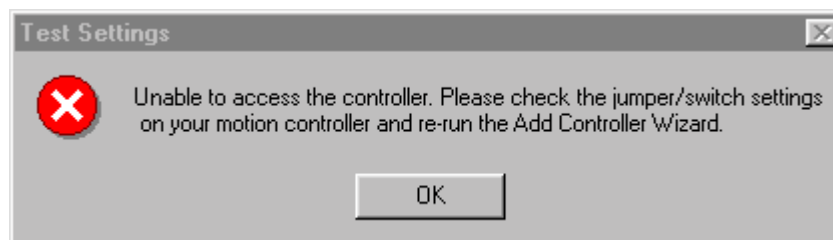
The ISA versions of the DCX Multi-axis Motion Controllers communicate with the PC via dual ported memory. The default BIOS settings of some Windows computers allow the operating system to utilize the area of memory required by the DCX motion Controllers. This BIOS setting will cause a memory conflict, the effect being that PMC's New Controller Wizard will be unable to properly detect and install a DCX motion controller.

Back in the days of DOS and Windows 3.X some users had to edit their config.sys file to configure the memory manager to exclude (not allow the PC to use) memory addresses D000:0000H to D000:0FFFh. Windows 2000/ME/NT/98 have done away with the old memory managers (remember EMM386) but the PC still craves memory. During the installation and configuration of a DCX controller using the New Controller Wizard, if a memory conflict is detected a message box will appear:

To resolve a memory conflict caused by BIOS settings, restart the PC and launch the CMOS Setup Utility. Usually the memory/resource allocation tables are found in the Advanced Settings section. Change the setting for the area of memory in which the DCX resides from **Available** to **Reserved**.
